### **Town Complex Study**

422 Main Road – Route 143

December 03, 2018

### **The Davenport Building – Existing Conditions**

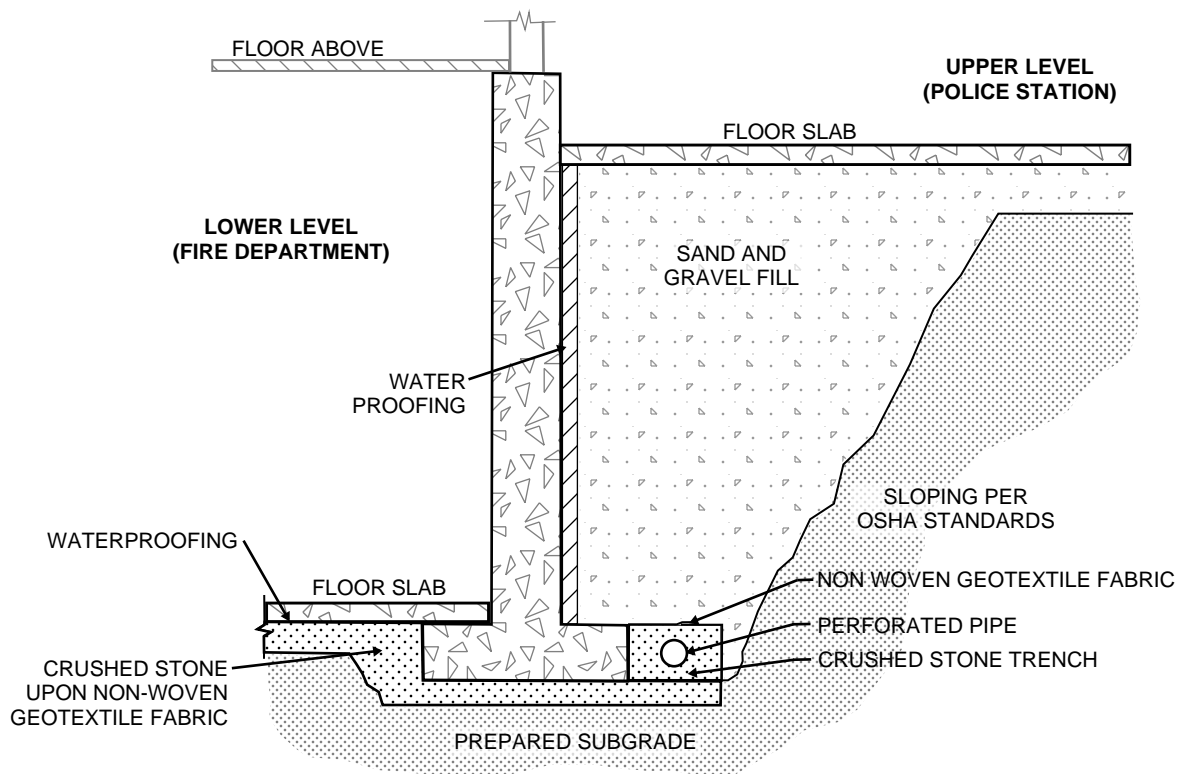
**TYPICAL FOUNDATION SECTION - UNDERDRAIN SYSTEM**  
**BASEMENT FOUNDATION, ENTRANCE SLAB**

Wet soils were observed in each boring at a depth of between 2.5 and 5 feet below ground surface, corresponding to approximate elevations of 91.5 and 94.2 feet. In addition, perched groundwater may be present during periods of wet weather. Therefore, we recommend that the building include perimeter drainage to control groundwater and surface water infiltration. The perimeter drainage system can consist of perforated PVC pipe, installed in a Crushed Stone trench, and wrapped in a non-woven geotextile fabric. Furthermore, we recommend that a Crushed Stone drainage layer be included beneath the lower level floor slab of the safety complex building. The Crushed Stone drainage layer and perimeter drain should be hydraulically connected to allow the water to flow away from the foundation via gravity. Clean-outs should be provided in the sub-slab and/or perimeter drainage system, to allow for future maintenance. Since it appears that the lower level will be partially below grade, we recommend that water proofing be provided below the slab, water-stops be included, and at a minimum, the below grade walls should be damp-proofed. We recommend that complete (membrane) waterproofing be strongly considered by the architect, depending on the planned use of below grade spaces, and final design and slab elevations. A typical detail of the underdrain system is shown on Sheet 2.

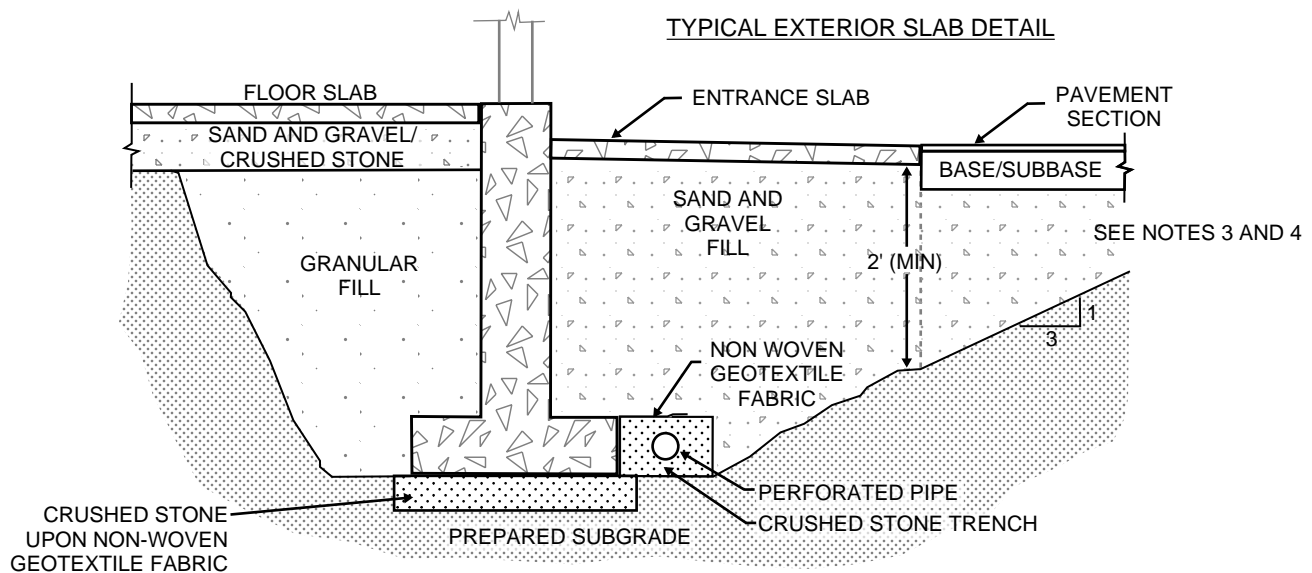
**TYPICAL FOUNDATION SECTION - NATURAL SOIL SUPPORT**  
**SLAB ON GRADE FOOTING, ENTRANCE SLAB**

Since the native Site soils are susceptible to disturbance due to their high silt content, we recommend that footing subgrades be over-excavated by six inches and that a minimum of six inches of Crushed Stone be placed upon the native soils to protect the subgrade from disturbance. A non-woven geotextile fabric should be placed between the native subgrade and Crushed Stone to maintain separation between the Crushed Stone and soil layers. Wet and/or disturbed soils encountered below slabs and footings should be removed and replaced with Crushed Stone.
