Russell Memorial Park

Town of Chesterfield ADA Transition Plan

May 2019

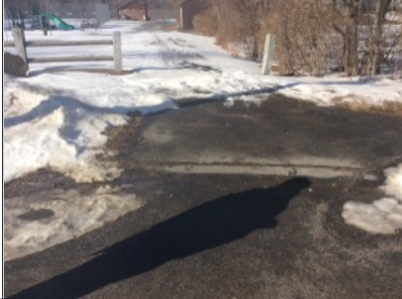
Surface openings > 1/2"	3"	Repair surface.	1	103	\$103
2	Route to Concession Stand and Baseball Field	Ext.		Exterior Access Route	Walkway

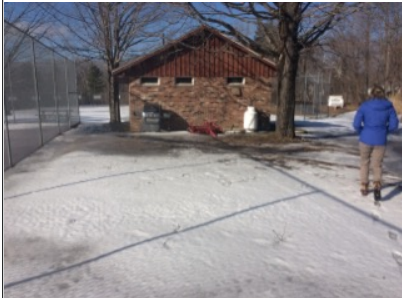
Accessible route not provided	-	Ensure an accessible route is provided. (Cost based on 90' long stone dust path to concession stand from tennis area.)	1	1026	\$1026
3	Baseball Field	Ext.		Exterior Access Route	Exterior

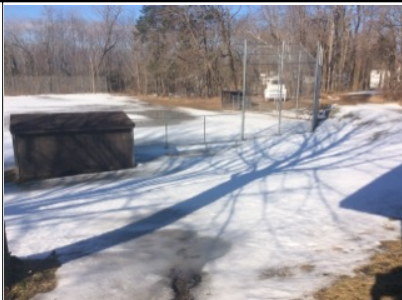
Accessible route not provided	-	Ensure an accessible route is provided. (Cost for 60' long stone dust path from concession stand.)	1	684	\$684
4	Wayside	Ext.		Exterior Access Route	Exterior

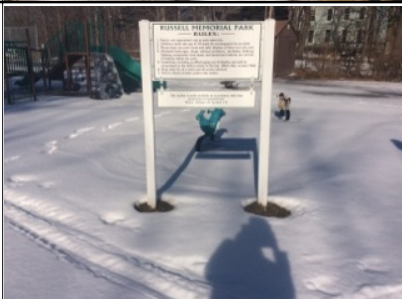
Accessible route not provided	-	Locate wayside on an accessible route.	1	0	\$0
Off-Street Parking Lot or Garage

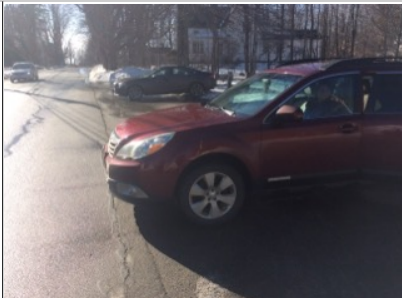
5	Street-Side Parking			Off-Street Parking Lot or Garage	N/A

Total # of parking Total # of designated accessible parking spaces Total # of designated van accessible spaces	12 0 0	Provide one van accessible space that is at least 132" wide and a marked access aisle that is at least 60" wide. Provide a sign with the bottom of the sign 60" min. above the ground and the top 96" max. above the ground. Add the designation "Van Accessible".	1	550	\$550

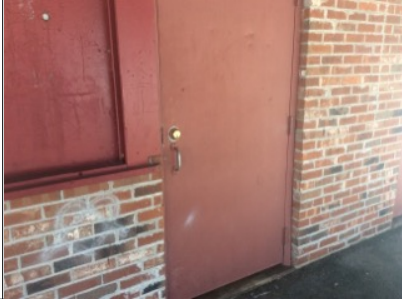
Hardware not operable with a closed fist Signage not provided	- -	Provide hardware that can be operable with one hand and not require tight grasping, pinching, or twisting of the wrist. Locate signage alongside the door on the latch side.	1	359	\$359
Service Counter												
7	Concession Stand	Ext.		Service Counter	N/A

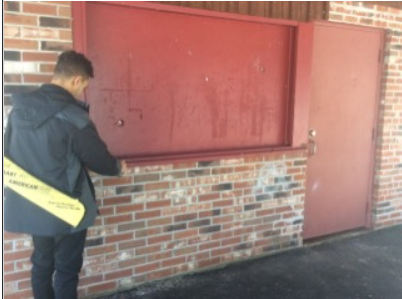
Counter > 36" high	38.5"	Provide a counter that is 36" max. above the ground or finish floor.	1	Labor	\$0
Picnic Tables												
8	Near Tennis Court	Ext.		Picnic Tables	N/A

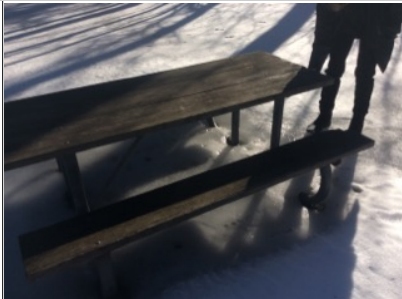
Toe or knee clearance at tables not provided	25"	Provide at least 1 dining surface (or ensure that 5% of dining surfaces) have toe and knee clearance.	1	700	\$700

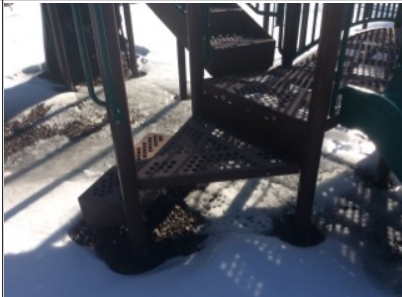
Play and Sport Areas												
Play Areas												
9	Playground	Ext.		Play Areas	N/A

No compliant transfer system	-	Alteration might be technically infeasible.	1	0	\$0

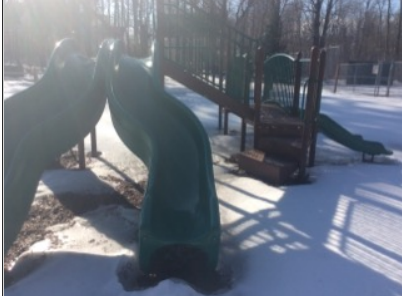
Surface not stable, firm, and slip-resistant	-	Repair surface and ensure that surface is firm, stable and slip-resistant (areas under and around play components).	1	6776	\$6776
11	Playground	Ext.		Play Areas	N/A

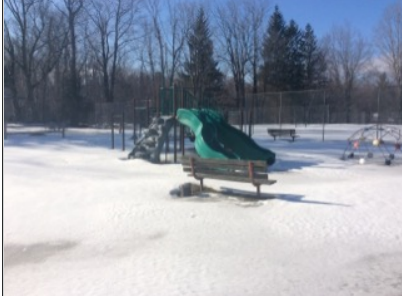
Accessible route not provided	-	Ensure an accessible route is provided. (Cost based on 90" long stone dust connecting the playgrounds.)	1	1026	\$1026
Field												
12	Baseball Field	Ext.		Field	Baseball

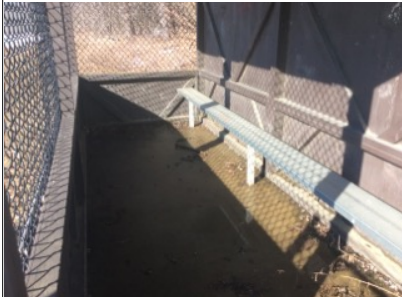
Accessible spaces not provided at team seating	-	Provide a 36" x 48" clear floor space at team seating. (Cost for 36" x 48" clear floor space (stone dust).)	2	45	\$90
13	Baseball Field	Ext.		Field	Baseball

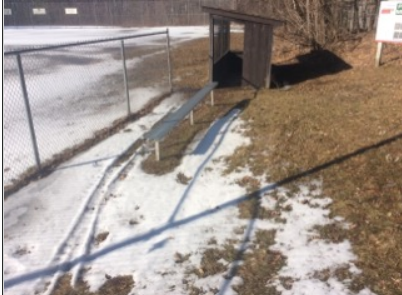
Accessible spaces not provided at sidelines seating	-	Provide a 36" x 48" clear floor space at sidelines seating. (Cost for 36" x 48" clear floor space (stone dust).)	2	45	\$90
