# Chesterfield Public Library

## Town of Chesterfield ADA Transition Plan

May 2019

### Public Library

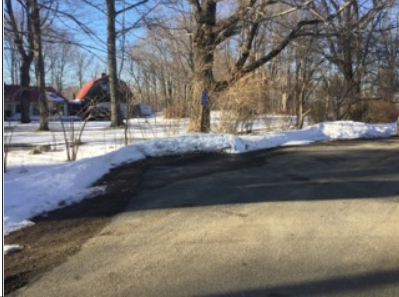
Access aisle not provided Sign bottom < 60" above finished grade	- 57"	Provide a marked access aisle that is at least 96" wide. Locate sign with the bottom of the sign 60" above the ground and the top of the sign 96" above the ground.	1	150	\$150
<b>Emergency Exit</b>												
2	Rear Exit	Ext.		Emergency Exit	N/A

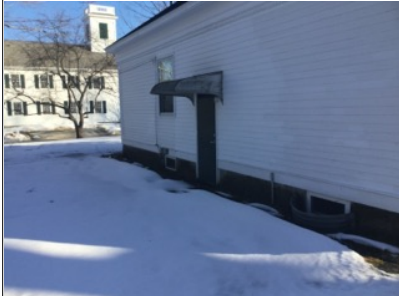
Emergency exit not on an accessible route	-	Provide an area for assisted rescue. In the inside, provide a sign with raised characters duplicated in braille. Ensure the sign has the International Symbol of Accessibility (ISA).  (Cost based on 60" x 60" concrete landing plus sign.)	1	498	\$498
<b>Access to Goods and Services</b>

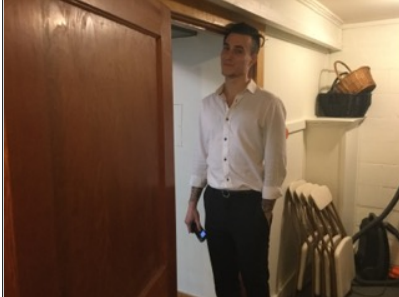
Minimum vertical clearance not provided	71"	Providing the minimum vertical clearance might be technically infeasible. Consider adding a sign that says, "Low Headroom" or "Low Ceiling".	1	0	\$0
<b>Doors, Doorways, &amp; Gates</b>												
4	Stairs	1		Doors, Doorways, & Gates	Other

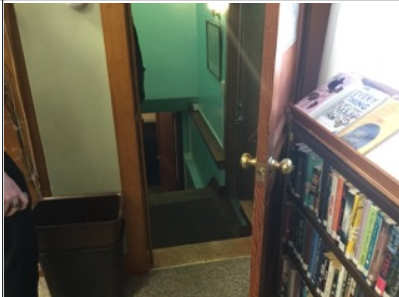
Clear width at door < 32" Hardware not operable with a closed fist	24" -	Widen the door so that there is 32" min. clear width. Provide hardware that can be operable with one hand and not require tight grasping, pinching, or twisting of the wrist.	1	1925	\$1925

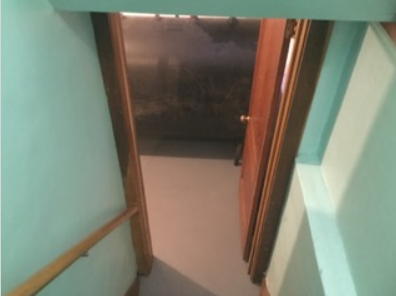
Clear width at door < 32" Hardware not operable with a closed fist	29.5" -	Widen the door so that there is 32" min. clear width. Provide hardware that can be operable with one hand and not require tight grasping, pinching, or twisting of the wrist.	1	1925	\$1925
6	Downstairs	B		Doors, Doorways, & Gates	Other

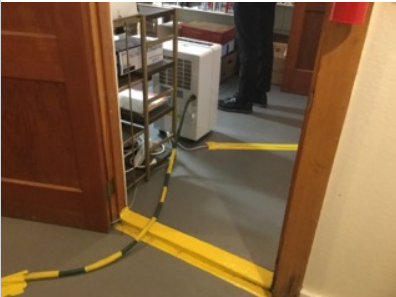
Threshold > 1/2" high	2"	Changes in level greater than 1/2" must be ramped. Consider providing a transition aluminum threshold ramp.	1	75	\$75
7	Single-User Toilet Room	B		Doors, Doorways, & Gates	Toilet Room

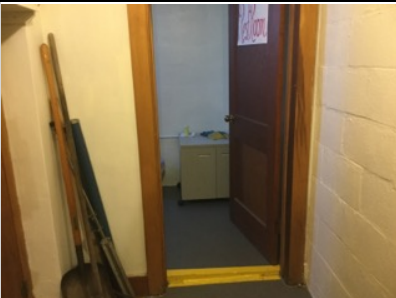
Threshold > 1/2" high Hardware not operable with a closed fist	2" -	Changes in level greater than 1/2" must be ramped. Consider providing a transition aluminum threshold ramp. Provide hardware that can be operable with one hand and not require tight grasping, pinching, or twisting of the wrist.	1	317	\$317

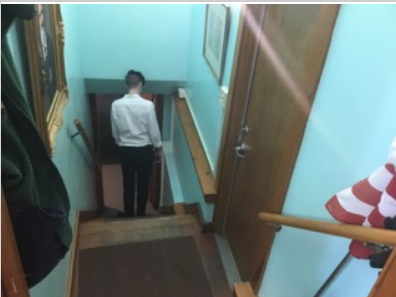
Minimum vertical clearance not provided Handrail not provided on both sides Handrails do not extend 12" from stairs	63" - -	Providing the minimum vertical clearance might be technically infeasible. Consider adding a sign that says, "Low Headroom" or "Low Ceiling". Provide handrail on both sides. At the top, ensure handrails extend horizontally above the landing for 12" min. beginning above the first riser nosing. Bottom. ensure handrails extend to one tread depth beyond the last riser.	1	1320	\$1320
<b>Signage</b>												
9	Reading Room	B		Signage	Designation

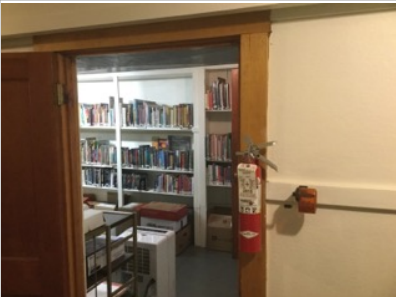
Not provided	-	Provide a sign with raised characters duplicated in braille. Locate sign alongside the door on the latch side.	1	116	\$116

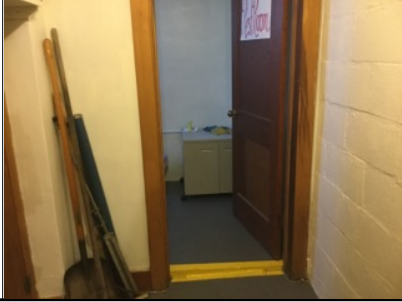
Not provided	-	Provide a sign with raised characters duplicated in braille. Locate sign alongside the door on the latch side.	1	116	\$116
<b>Dining or Work Surfaces</b>												
11	Reading Room	1		Dining or Work Surfaces	Work Surface

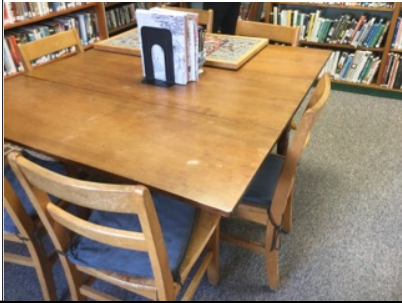
Knee or toe clearance not provided	23"	Provide at least one work surface with 27" min. knee clearance.	1	350	\$350
12	Circulation Desk	1		Dining or Work Surfaces	Work Surface

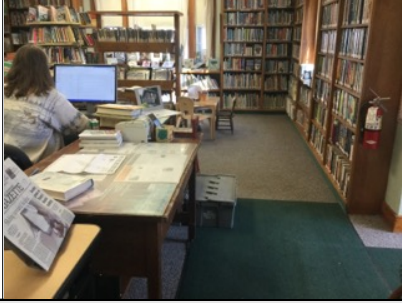
Knee or toe clearance not provided Surface not stable, firm, and slip-resistant	22.5" -	Provide one work surface with 27" min. knee clearance. Securely attach mat.	1	350	\$350
<b>Toilet &amp; Bathing Rooms</b>												
<b>Overall Access</b>												
13	Single-User Toilet Room	B		Overall Access	Toilet Room
