Chesterfield Town Hall

Town of Chesterfield ADA Transition Plan

May 2019

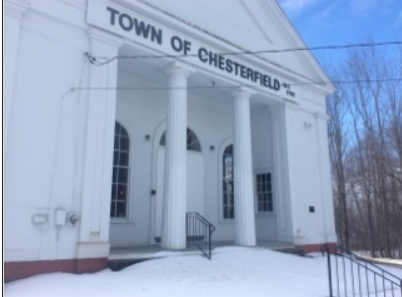
ID	Location	Floor	Room	Element	Type	Photo	Issues	Current Measure	Recommendations	Quantity	Price	Cost Estimation
Approach and Entrance												
Entrance												
1	Main Entrance	Ext.		Entrance	Main Entrance

Entrance not on an accessible route Directional sign to accessible entrance not provided	- -	Provide a directional sign indicating the location of the nearest accessible entrance.	1	173	\$173
Access to Goods and Services												
Stairways												
2	Main Entrance	Ext.		Stairways	Exterior

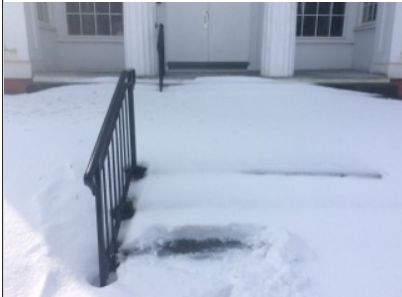
Handrail not provided on both sides Handrails do not extend 12" from stairs	- -	Provide handrail on one side. Ensure handrails extend horizontally above the landing for 12" min. beginning above the first riser nosing. Ensure handrails extend to one tread depth beyond the last riser. (Cost for 4 extensions and a compliant metal handrail.)	1	1170	\$1170
Signage												
3	Main Hall	1		Signage	Egress

- Provide compliant handrails: \$1170
- Miscellaneous corrective actions (toilet rooms, signage, visible and audible alarm, etc.): \$822

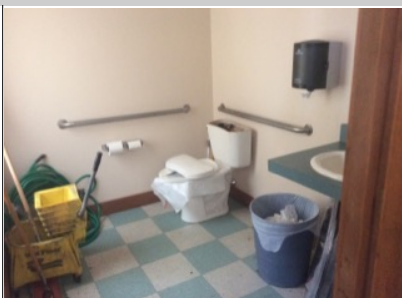
Toilet & Bathing Rooms												
Overall Access												
4	Single-User Toilet Room	1		Overall Access	Toilet Room

Audible and visible alarms not provided	-	When fire system is updated, ensure that a visible and audible fire alarm is installed.	1	346	\$346

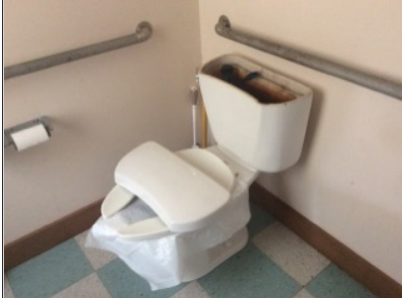
ID	Location	Floor	Room	Element	Type	Photo	Issues	Current Measure	Recommendations	Quantity	Price	Cost Estimation
Single-User Toilet												
5	Single-User Toilet Room	1		Single-User Toilet	N/A

Flush control not on open side	-	Relocate the flush control to the open/transfer side.	1	187	\$187
