# Chesterfield Town Offices

## Town of Chesterfield ADA Transition Plan

May 2019

### Chesterfield Town Offices

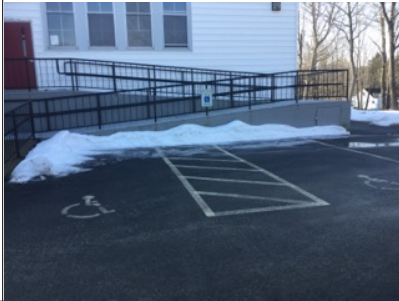
Access aisle < 96" wide at van space Sign bottom < 60" above finished grade	56" -	Provide a marked access aisle that is at least 96" wide. Locate sign with the bottom of the sign 60" min. above the ground and the top of the sign 96" max. above the ground.	1	150	\$150
<b>Ramp</b>												
2	Accessible Entrance	Ext.		Ramp	Exterior

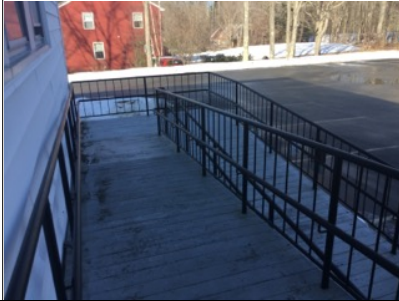
Running slope >1:12 (8.33%)	9.6%	Reduce running slope to be no steeper than 1:12 (8.33%).	1	12000	\$12000
<b>Access to Goods and Services</b>												
<b>Interior Access Route</b>												
3	Tax Collector and Treasurer	1		Interior Access Route	N/A

The ramp leading to the accessible entrance has a slope greater than the maximum allowed.

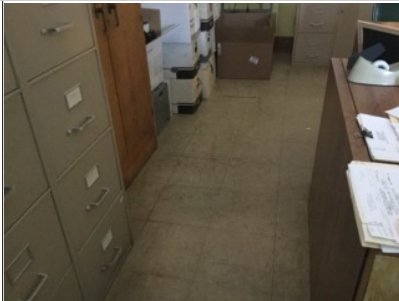
Route < 36" wide	29"	Ensure that a clear width of 36" min. is maintained at the accessible route.	1	Labor	\$0

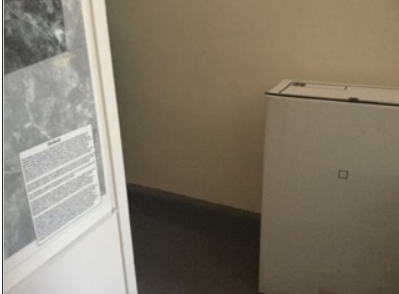
4	Assessors	1		Interior Access Route	N/A

Route < 36" wide	28.5"	Ensure that a clear width of 36" min. is maintained at the accessible route by moving the box.	1	Labor	\$0

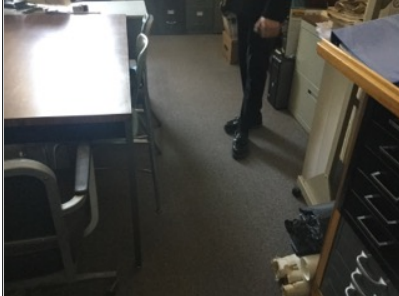
ID	Location	Floor	Room	Element	Type	Photo	Issues	Current Measure	Recommendations	Quantity	Price	Cost Estimation
5	Assessors	1		Interior Access Route	N/A

Route < 36" wide	22"	Ensure that a clear width of 36" min. is maintained at the accessible route.	1	Labor	\$0
6	Town Clerk	1		Interior Access Route	N/A

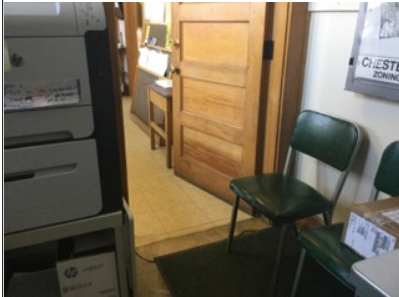
Route < 36" wide	21"	Ensure that a clear width of 36" min. is maintained at the accessible route.	1	Labor	\$0
7	Single-User Toilet Room	1		Interior Access Route	N/A

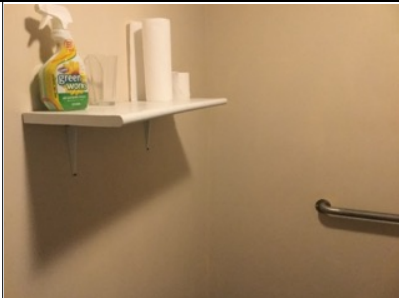
Obstructed by protruding objects	11.25"	Relocate or remove shelf so it does not protrude into the circulation path.	1	Labor	\$0
<b>Doors, Doorways, &amp; Gates</b>												
8	Meeting Room	1		Doors, Doorways, & Gates	Meeting Room

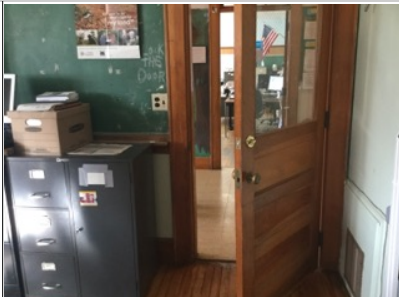
Maneuvering clearance(s) not provided	9"	Relocate the file cabinet to maintain the 18" min. maneuvering clearance at the door.	1	Labor	\$0
9	Single-User Toilet Room	1		Doors, Doorways, & Gates	Toilet Room

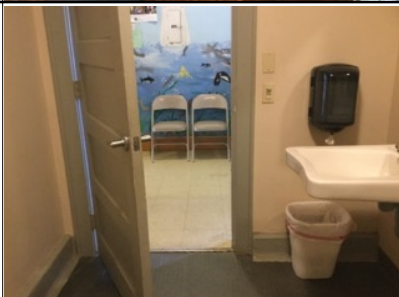
Maneuvering clearance(s) not provided	8.5"	Provide an automatic door opener.	1	1530	\$1530

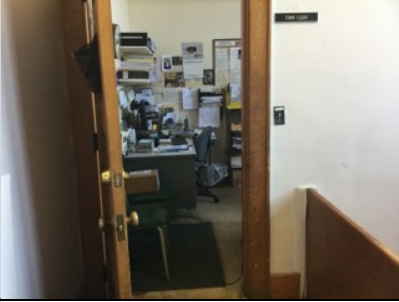
ID	Location	Floor	Room	Element	Type	Photo	Issues	Current Measure	Recommendations	Quantity	Price	Cost Estimation
10	Town Clerk	1		Doors, Doorways, & Gates	Office

Maneuvering clearance(s) not provided	14"	Keep door open during business hours.	1	Labor	\$0
11	Throughout Building	1		Doors, Doorways, & Gates	Circulation

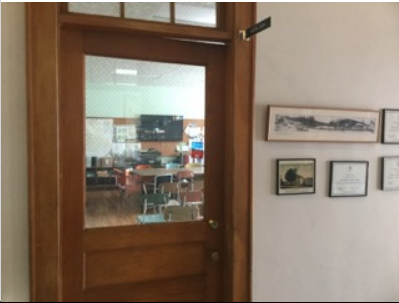
Hardware not operable with a closed fist	-	Provide hardware that can be operable with one hand and not require tight grasping, pinching or twisting of the wrist.	7	242	\$1694
12	Stairway Entrance Door Next to Accessible Entrance	1		Doors, Doorways, & Gates	Other

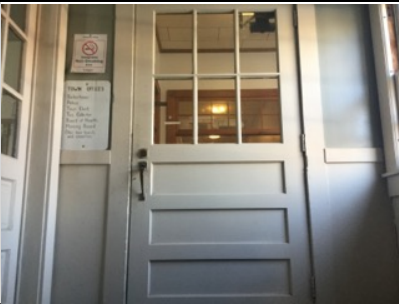
Hardware not operable with a closed fist	-	Provide hardware that can be operable with one hand and not require tight grasping, pinching, or twisting of the wrist.	1	242	\$242
<b>Signage</b>												
13	Throughout Building	1		Signage	Designation

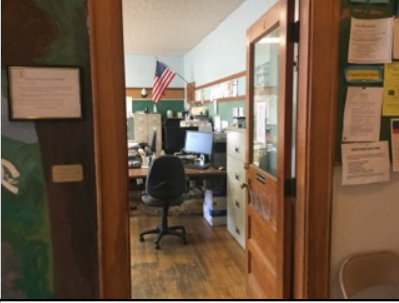
Raised characters not provided Braille not provided	- -	Provide text with raised characters duplicated in braille.	7	116	\$812

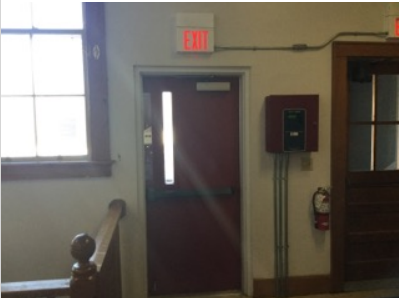
14	Accessible Entrance	1		Signage	Egress

Raised characters not provided Braille not provided	- -	Provide text with raised characters duplicated in braille.	1	116	\$116

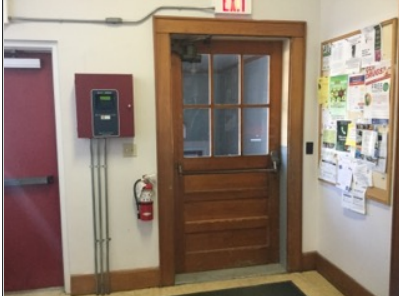
ID	Location	Floor	Room	Element	Type	Photo	Issues	Current Measure	Recommendations	Quantity	Price	Cost Estimation
15	Stairway Entrance Door Next to Accessible Entrance	1		Signage	Egress

Raised characters not provided Braille not provided	- -	Provide text with raised characters duplicated in braille.	1	116	\$116
16	Single-User Toilet Room	1		Signage	Designation

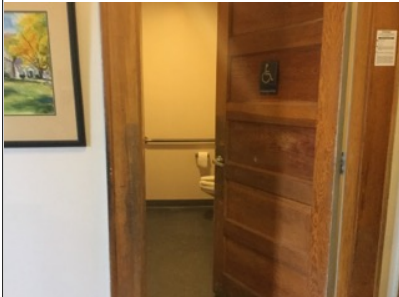
Braille not provided Raised characters not provided Sign not located on the latch side of the door	- - -	Provide text with raised characters duplicated in braille. Locate sign at permanent rooms alongside the door on the latch side.	1	116	\$116
<b>Service Counter</b>												
17	Police Station Counter and Finger Printing Station	1		Service Counter

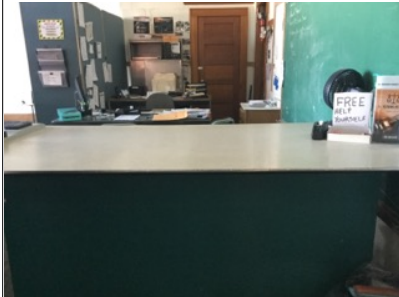
Counter > 36" high	39.75"	Provide a counter that is 36" max. above the ground or finish floor.	1	440	\$440
<b>Dining or Work Surfaces</b>												
18	Select Board	1		Dining or Work Surfaces	Work Surface

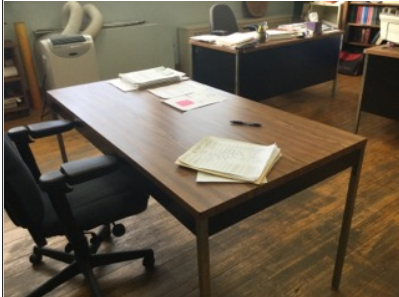
Knee or toe clearance not provided	26.5"	Provide a work surface with 27" min. knee and toe clearance.	1	350	\$350

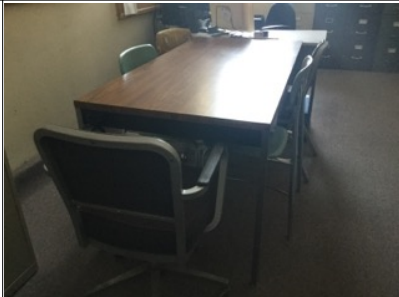
19	Assessors	1		Dining or Work Surfaces	Work Surface

Knee or toe clearance not provided	26.25"	Provide a work surface with 27" min. knee and toe clearance.	1	350	\$350

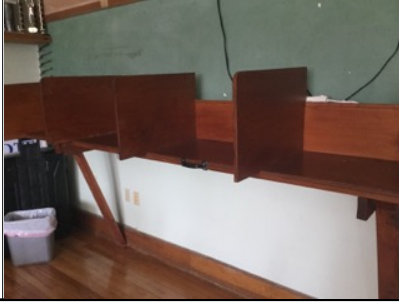
ID	Location	Floor	Room	Element	Type	Photo	Issues	Current Measure	Recommendations	Quantity	Price	Cost Estimation
20	Voting Area in Meeting Room	1		Dining or Work Surfaces	Work Surface

Top of dining/work surface < 28" or > 34"	41"	Provide a work surface with top between 28"-34" above the floor and 27" clear height underneath.	1	350	\$350
<b>Toilet &amp; Bathing Rooms</b>												
<b>Lavatory</b>												
21	Single-User Toilet Room	1		Lavatory	N/A

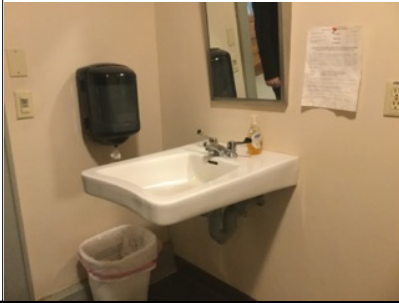
Plumbing underneath is exposed	-	Insulate or otherwise configure pipe to prevent contact at lavatory.	1	46	\$46
<b>Single-User Toilet</b>												
22	Single-User Toilet Room	1		Single-User Toilet	N/A

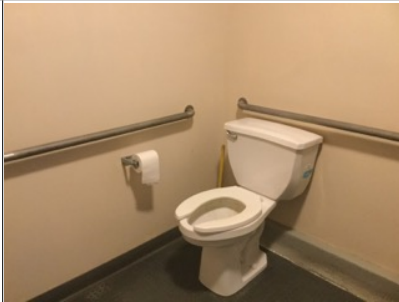
Flush control not on open side Hook located > 48" high	- 64.25"	Relocate the flush control to the transfer/open side. Locate hook no higher than 48" above the finish floor.	1	262	\$262
<b>Additional Access</b>												
<b>Drinking Fountains</b>

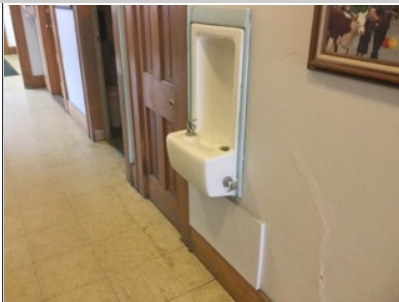
23	Hallway	1		Drinking Fountains	Low

Operable parts malfunctioning No drinking fountain provided for standing users No drinking fountain provided for seated users	- - -	Replace with a PãŠo drinking fountain.	1	2108	\$2108
