West Chesterfield Post Office

Town of Chesterfield ADA Transition Plan

May 2019

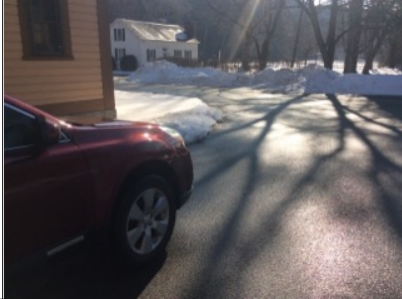
ID	Location	Floor	Room	Element	Type	Photo	Issues	Current Measure	Recommendations	Quantity	Price	Cost Estimation
Approach and Entrance												
Off-Street Parking Lot or Garage												
1	Parking Area	Ext.		Off-Street Parking Lot or Garage	N/A

Total # of parking	3	Provide a van accessible space that is at least 96" wide and a marked access aisle that is at least 96" wide. (Sign is not required for four or fewer parking spaces.)	1	150	\$150
Access to Goods and Services												
Doors, Doorways, & Gates												
2	Entrance	Ext.		Doors, Doorways, & Gates

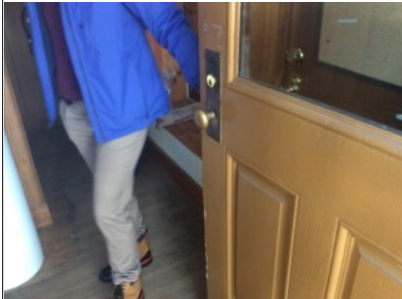
Hardware not operable with a closed fist	-	Provide hardware that can be operable with one hand and not require tight grasping, pinching, or twisting of the wrist.	1	242	\$242
3	Single-User Toilet Room	1		Doors, Doorways, & Gates	Toilet Room

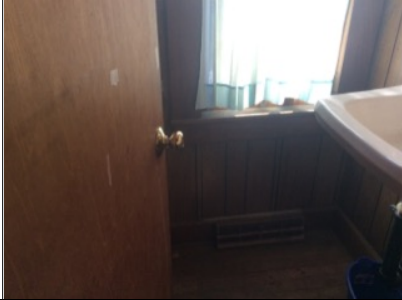
Hardware not operable with a closed fist	-	Provide hardware that can be operable with one hand and not require tight grasping, pinching, or twisting of the wrist.	1	242	\$242

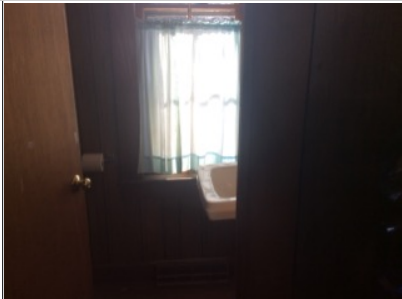
Signage												
4	Single-User Toilet Room	1		Signage	Designation

Not provided	-	Provide a sign with raised characters duplicated in braille. Locate sign alongside the door on the latch side.	1	116	\$116
Toilet & Bathing Rooms
